Manhole Inspection Summary

Manhole # S25G__015MH

Insp Date: **8/30/07 10:20 AM**

Location Address: **2 CAREY ST**

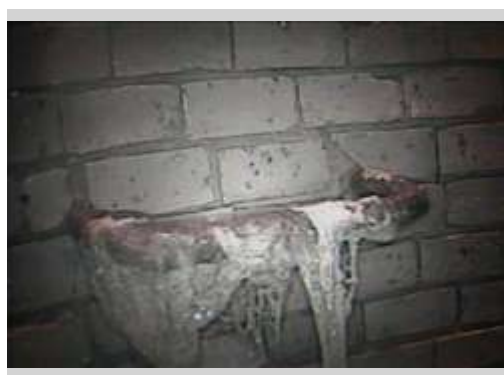
Defect 4

☒ **Evidence Of Surcharge**

Depth: **6** (ft.) ☐ Active Surcharge Present

SURCHARGE EVIDENCE ON STEPS

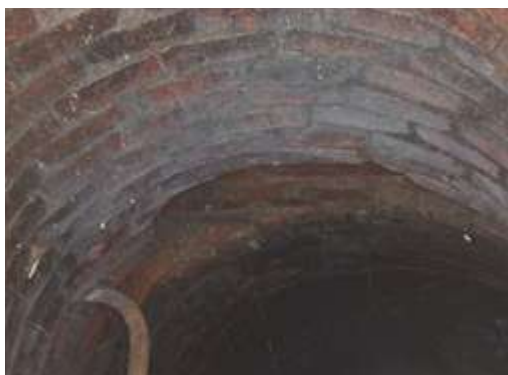
Defect 3

Comments **MASSIVE BARREL DETERIORATION**

Condition: ☐ Sound ☐ Cracked ☐ Root Intrusion ☐ Loose Brick ☒ **Deteriorated**

MASSIVE DETERIORATION OF
BARREL

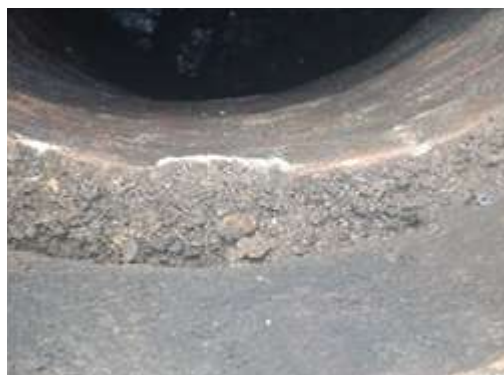
Defect 2

Offset: **2** (in.)

FRAME OFFSET

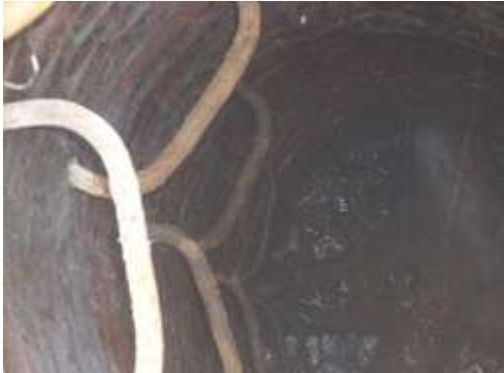
Defect 1

Count: **11** Missing: **0** ☒ **Corroded**

CORRODED STEPS

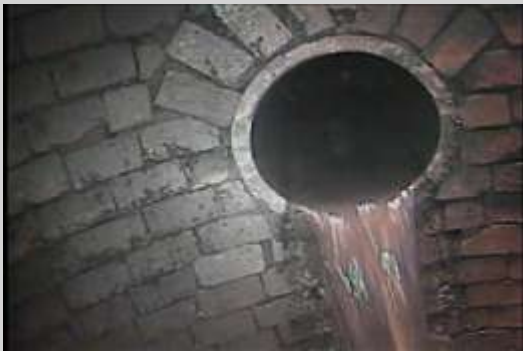
4 O'Clock Inflow

Pipe Height: **10.8** (in.) Rod and Bar (Angled)
Pipe Material: **Clay** ☐ Pipe Lined
Invert Depth: **11.76** (ft.) Flow Characteristics: **Slow**
Deposits: ☐ None ☐ Mud ☐ Sludge ☒ Debris ☐ Grease
Silt Depth: **3** (in.) Deposits Extent: **Medium**
Infiltration: **None** Pipe Seal Cond: **Sound**

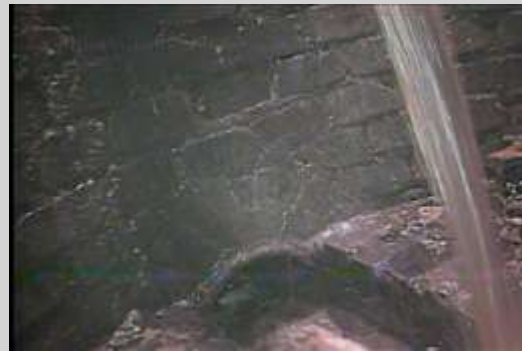
Drop In @ 4 O'Clock

Drop: **Outside** Rod and Bar
Angled: **Yes** Reading: **15.46** (ft.)
Inv Depth: **16.46** (ft.)
Drop Condition: **Clogged**

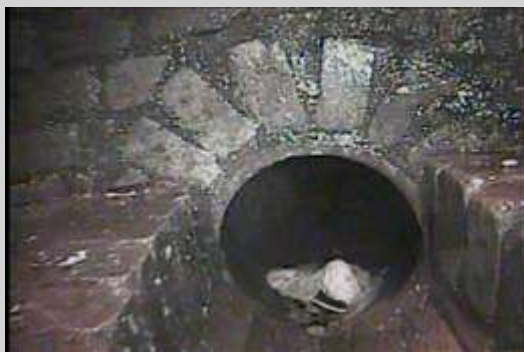
9 O'Clock Inflow

Deposits: ☐ None ☐ Mud ☐ Sludge ☒ **Debris** ☐ Grease

Silt Depth: **2** (in.) Deposits Extent: **Light**
